Manhole Inspection Summary

Manhole # S23E1_004MH

Insp Date: **7/9/08 1:32 PM**

Location Address: **Behind 2520 Hollins Ferry Rd.**

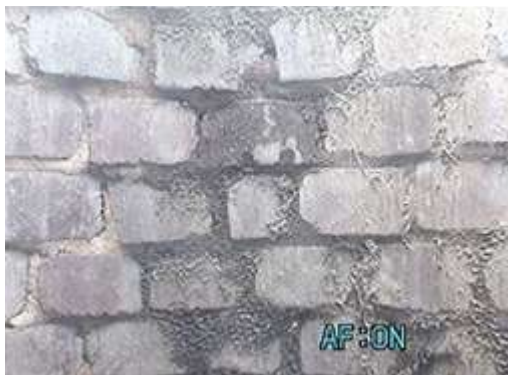
Defect 2

Infiltration: ☐ None ☐ Joint ☐ Cracks ☒ **Mortar** ☐ Roots ☐ Wall

Infiltration at corbel from mortar

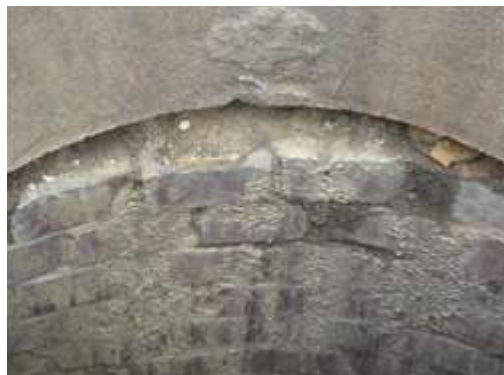
Defect 1

Condition: ☐ Sound ☐ Cracked ☐ Root Intrusion ☒ **Loose Brick** ☐ Deteriorated

Infiltration: ☐ None ☒ **Joint** ☐ Cracks ☒ **Mortar** ☐ Roots ☐ Wall

Missing brick and mortar at frame and chimney joint, signs of infiltration

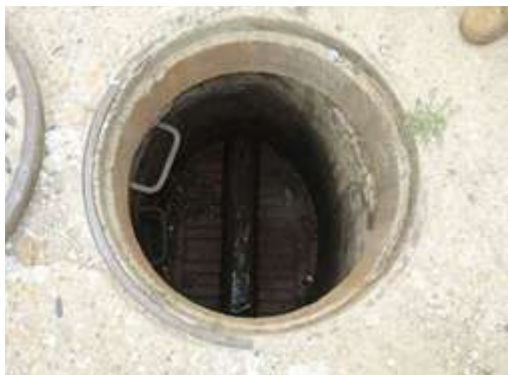
Defect

Frame Offset: **1** (in.)

☒ **Leaks**

Frame offset
